Cisco RF Gateway 1 Software Release Notes, Release 2.02.16

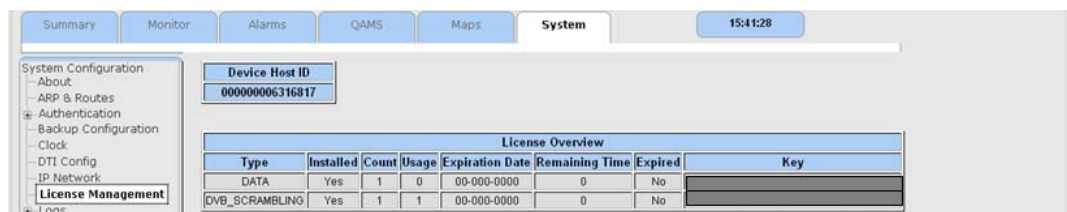
For systems requiring a license upgrade, a licensing capable RF Gateway 1 provides the operator with a new tree menu, located under the System tab, *License Management*. It provides an FTP mechanism to transfer license files to the device. It is recommended that the operator monitor the file transfer status using feedback from the FTP server.
