Checklist for Troubleshooting HyperFlex Server Discovery Issues

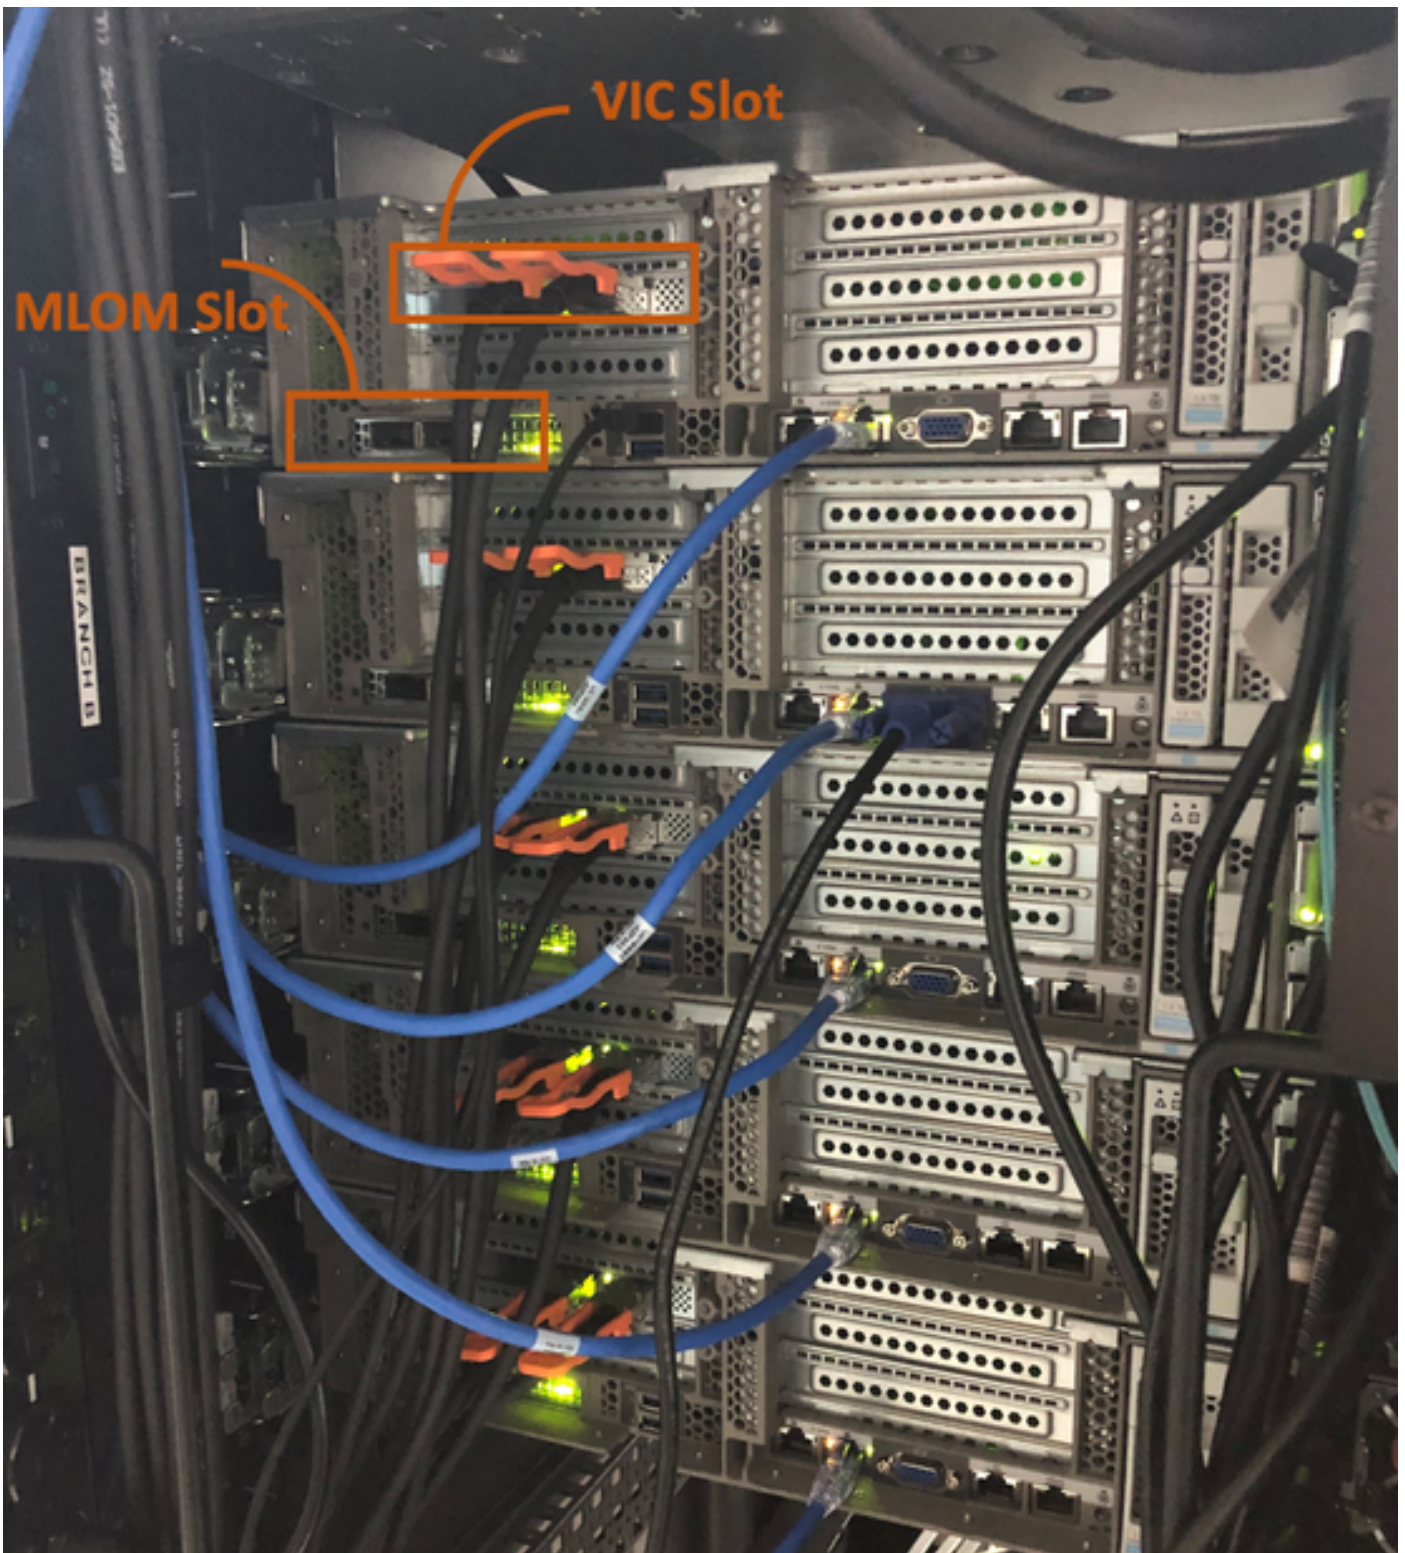
For HyperFlex servers (example shows a C240M5) make sure that the modular LAN on Motherboard (MLOM) slot is cabled to the Fabric Interconnects (FIs) so discovery can occur.

In this scenario, the server will not discover because the Virtual Interface Card (VIC) slot is being plugged into the FIs.

MLOM slot should be plugged into the FIs for discovery to complete. (MLOM is mandatory for discovery of HyperFlex servers)

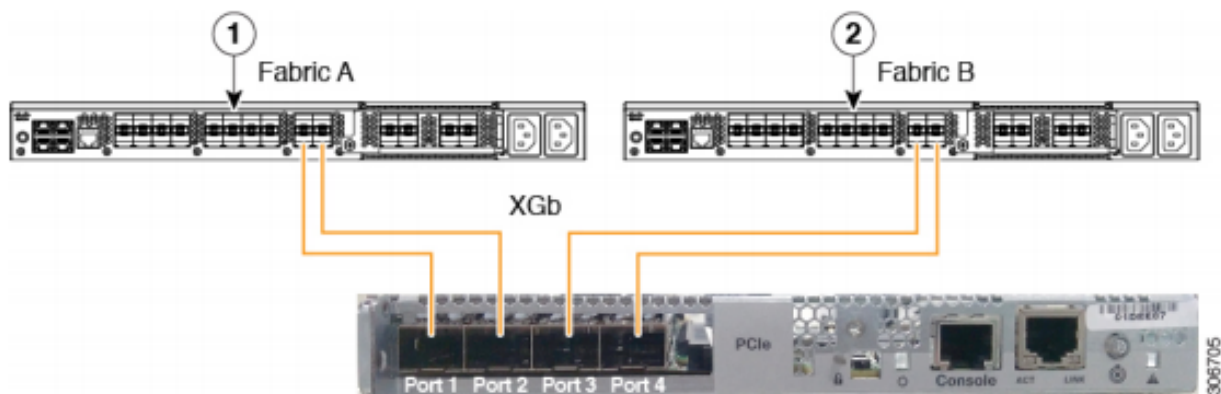
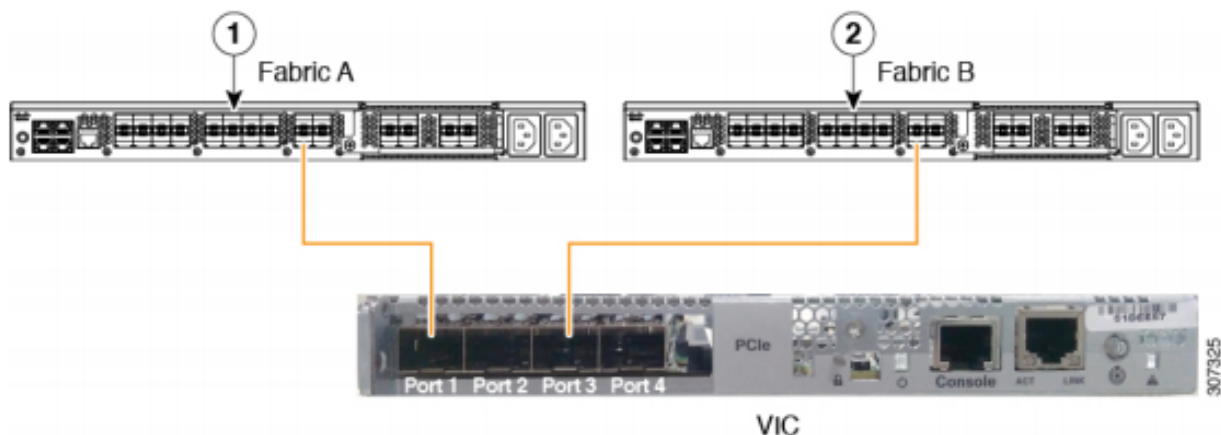
Figure 2: Direct Connect Cabling Configuration with Cisco VIC 1455 (2-Port Linking)

Ports 1 and 2 must connect to same Fabric Interconnect, i.e. Fabric-A.

Ports 3 and 4 must connect to same Fabric Interconnect, i.e. Fabric-B.

This is due to the internal port-channeling architecture inside the card.

Caution: Do not connect port 1 to Fabric Interconnect A, and port 2 to Fabric Interconnect B. Use ports 1 and 3 only. Using ports 1 and 2 results in discovery and configuration failures.

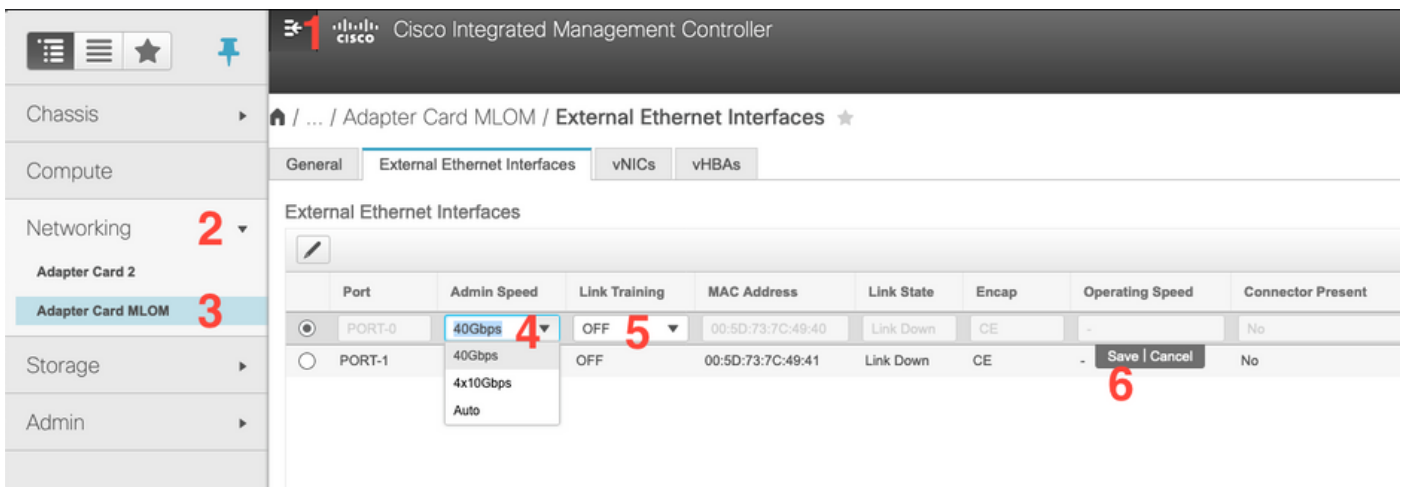
Change Admin Speed

If the wrong speed/training is chosen, then the links may not come up and will not get "link light."

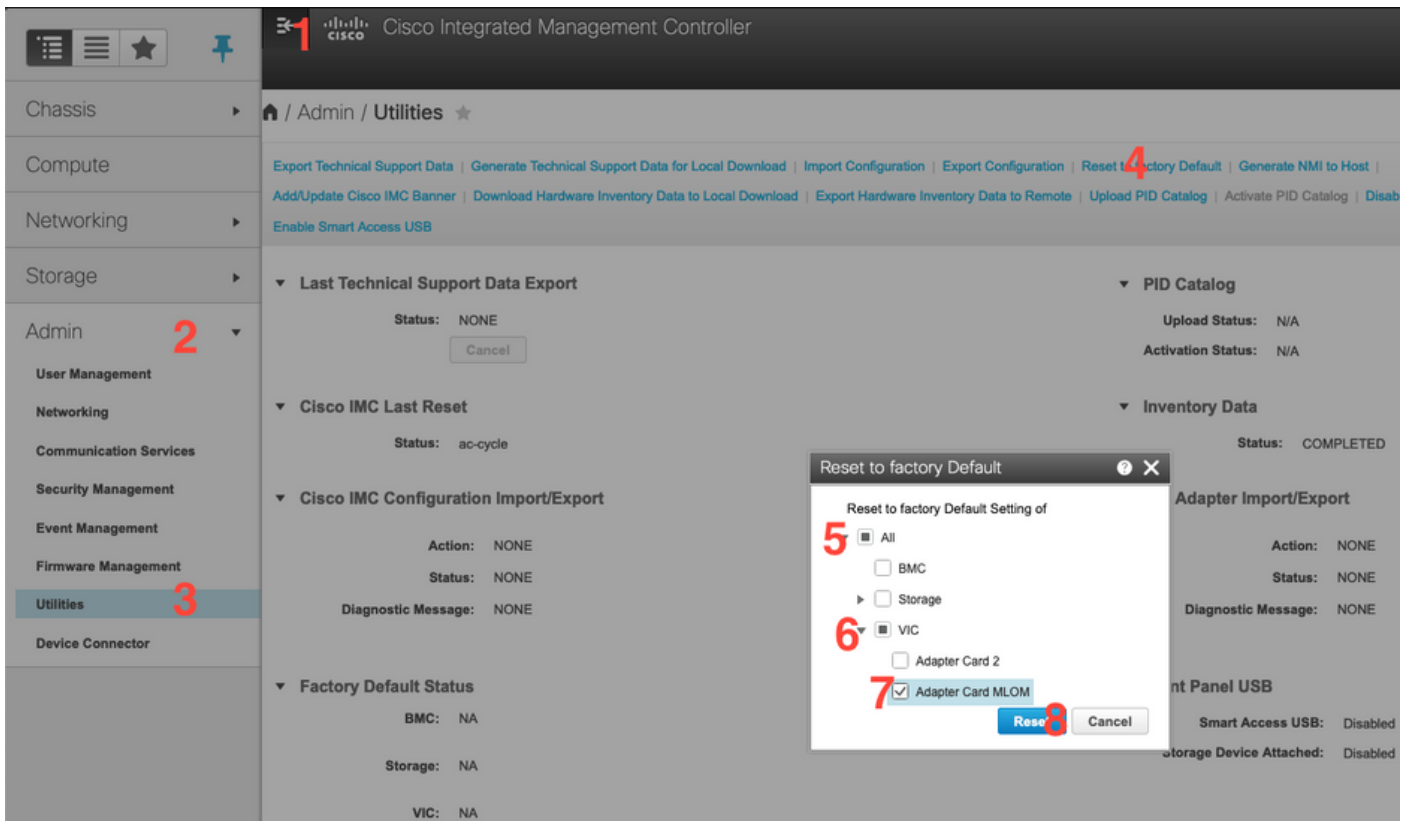
Reset to Factory Default

Doing a "reset to factory" from the BIOS/[F8] menu may not reset the VIC configuration.

Resetting via the CIMC web GUI does give the option to reset the VIC configuration to factory default.

5. Reboot Server and perform CIMC Reset to Factory Defaults. (Press the "F8" key to enter the "CIMC Config", Under Factory Defaults select "CIMC Factory Default. Hit F10 to Save)

6. Pull Power cables for 30 seconds.

7. Reconnect 10G cables.

8. Reconnect power cables and power on.
