ASA 8.4(4): Certain Identity NAT Configuration Disallowed

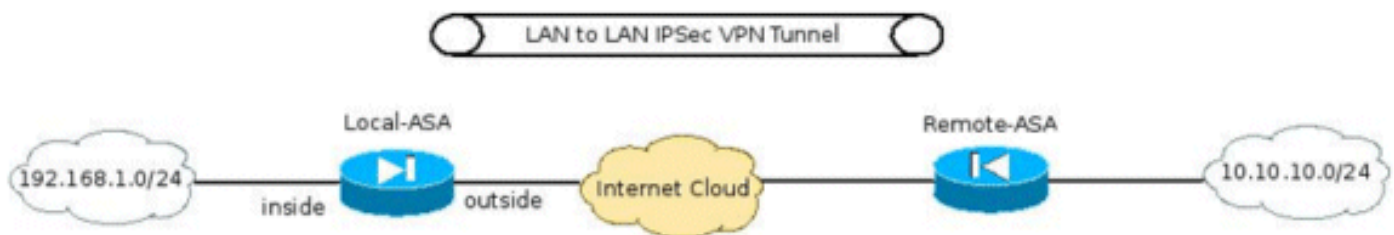
This has resulted in another unforeseen problem. For example, consider the scenario where the user has a VPN tunnel terminating on the ASA and wants to allow the "inside" subnet to be able to talk to the remote VPN subnet.

When this ASA is upgraded to 8.4(4) or higher, this NAT command will not be present in the ASA's running-config and this error will be printed on the ASA's console:

ERROR: 192.168.1.0-192.168.1.255 overlaps with inside standby interface
  address
ERROR: NAT Policy is not downloaded

As a result, traffic between subnets 192.168.1.0/24 and 10.10.10.0/24 will no longer flow through the VPN tunnel.

- Make the NAT command as specific as possible before upgrading to 8.4(4) so the mapped interface is not "any". For example, the above NAT command can be changed to the interface through which the Remote VPN subnet is reachable (named "outside" in the above scenario):

nat (inside,outside) source static obj-192.168.1.0 obj-192.168.1.0 destination
  static obj-10.10.10.0 obj-10.10.10.0

```
- If the above workaround is not possible, complete these steps: When the ASA is running 8.4(4) or higher, remove the standby IP address assigned to the interface. Apply the NAT command. Re-apply the standby IP address on the interface. For example:

ciscoasa(config)#
interface Ethernet0/0 ciscoasa(config-if)# ip address 192.168.1.1 255.255.255.0
ciscoasa(config-if)# exit ciscoasa(config)# nat (inside,any) 1 source static obj-192.168.1.0
obj-192.168.1.0 destination static obj-10.10.10.0 obj-10.10.10.0 ciscoasa(config)# interface
Ethernet0/0 ciscoasa(config-if)# ip address 192.168.1.1 255.255.255.0 standby 192.168.1.2
