排除CVP服务器因IP地址更改而无法访问的故障

本文档介绍如何在IP地址更改后对OAMP中客户语音门户(CVP)不可达状态进行故障排除。

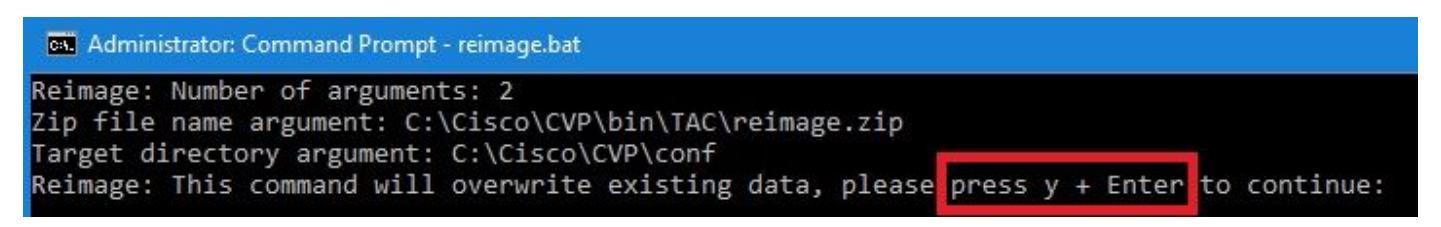
键入y并按Enter继续。

步骤2.在CVP服务器的命令提示符下,导航到C:\Cisco\CVP\bin\TAC\并运行reimage.bat。
