Checklist for Troubleshooting HyperFlex Server Discovery Issues

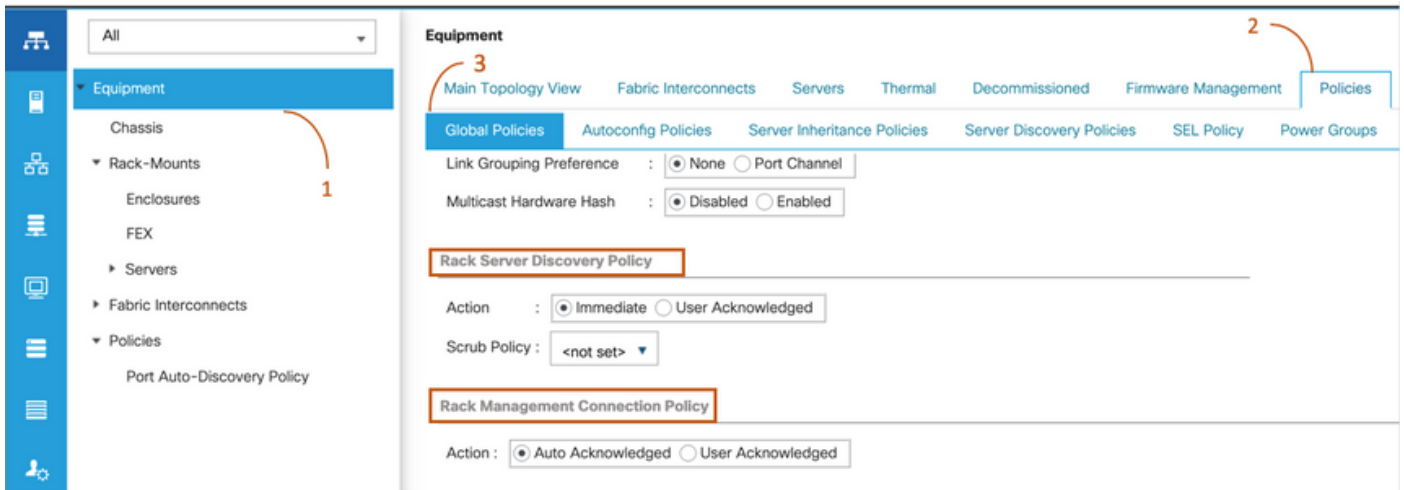
Make sure the Rack server Discovery Policy and the Rack Management Connection Policy have

not be altered

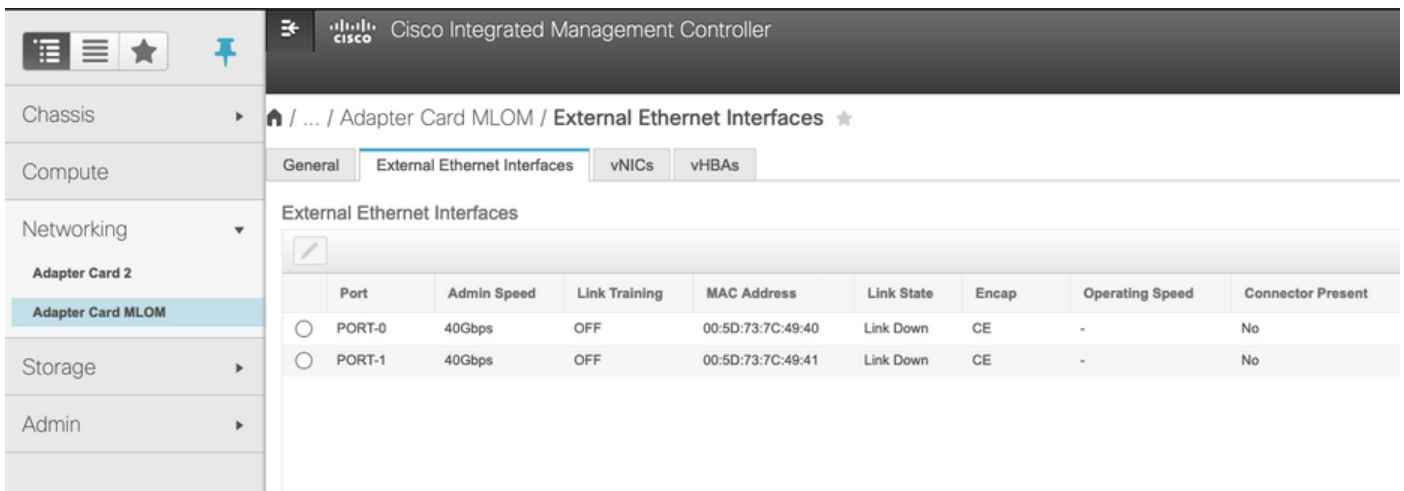
View VIC configuration via CIMC web GUI

If the wrong speed/training is chosen, then the links may not come up and will not get "link light."

To resolve for a UCSM Integrated server

1. Connect keyboard/monitor
2. [F8] to configure CIMC and enter Internet Protocol (IP) address ([Configure CIMC](#))
3. Connect the management port to network/laptop
4. Access newly configured CIMC IP to access CIMC Web Graphical User Interface (GUI) and make the following changes
