Troubleshooting Hardware and Related Issues on the MSFC, MSFC2, and MSFC2a

This document helps to troubleshoot issues with the Multilayer Switch Feature Card (MSFC) and the MSFC2 for the Cisco Catalyst 6500/6000 series switches and the Cisco 7600 series routers.

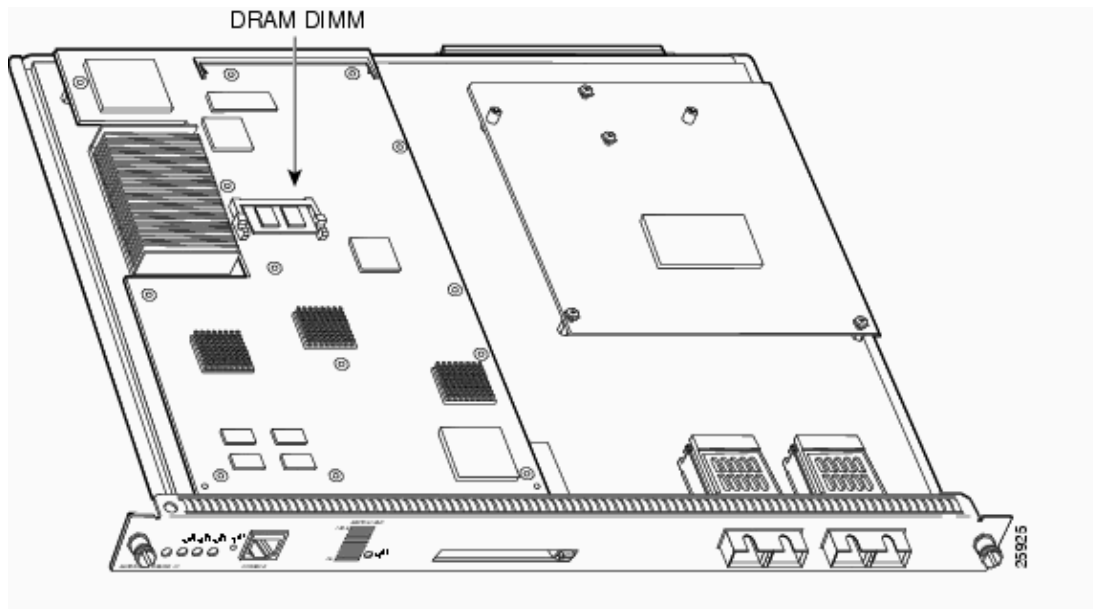
Two DRAM slots are stacked on top of one another on the MSFC.

Note: This image does not show the stacked slots.

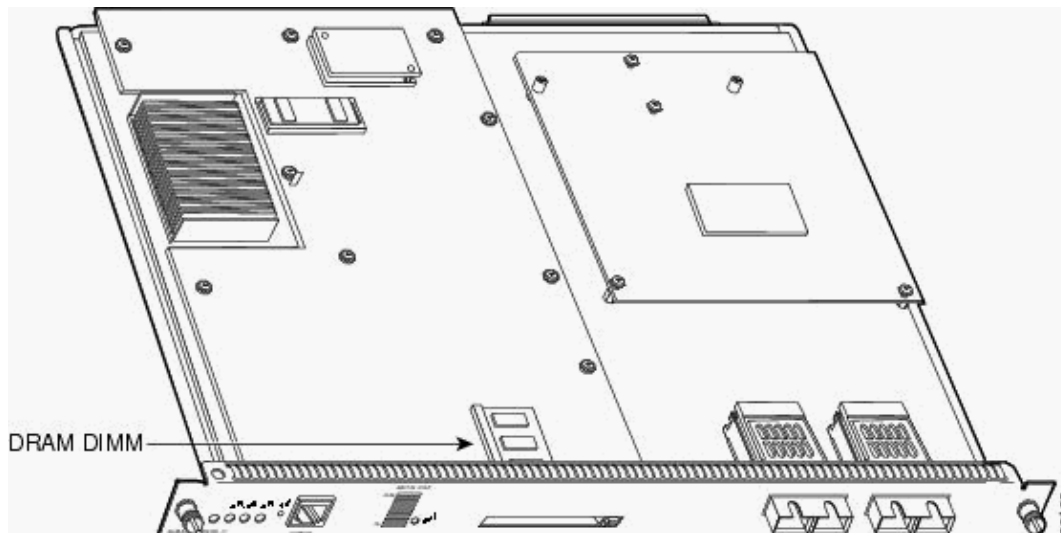
MSFC2 That Shipped Before November 2001 DRAM DIMM Location

The MSFC2 has only one DRAM slot.

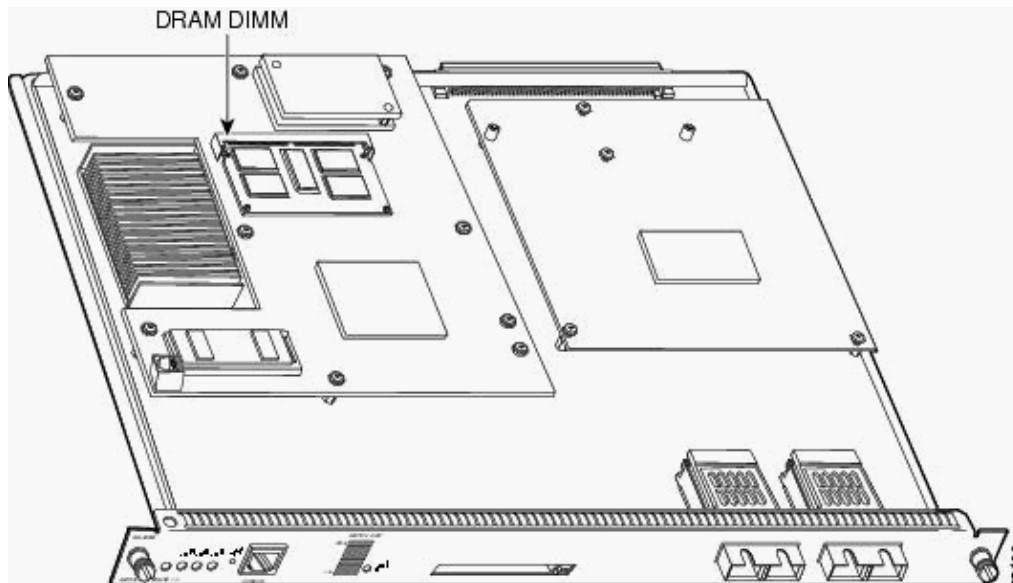
MSFC2 That Shipped After November 2001 DRAM DIMM Location

The MSFC2 has only one DRAM slot.
