Troubleshoot Cisco Headset 5XX Series

This document describes how to troubleshoot the Cisco headset 500 series. In Cisco Unified Communications Manager (CUCM) version 12.5(1)SU1, you are able to provide headset administration, inventory, and configuration management.

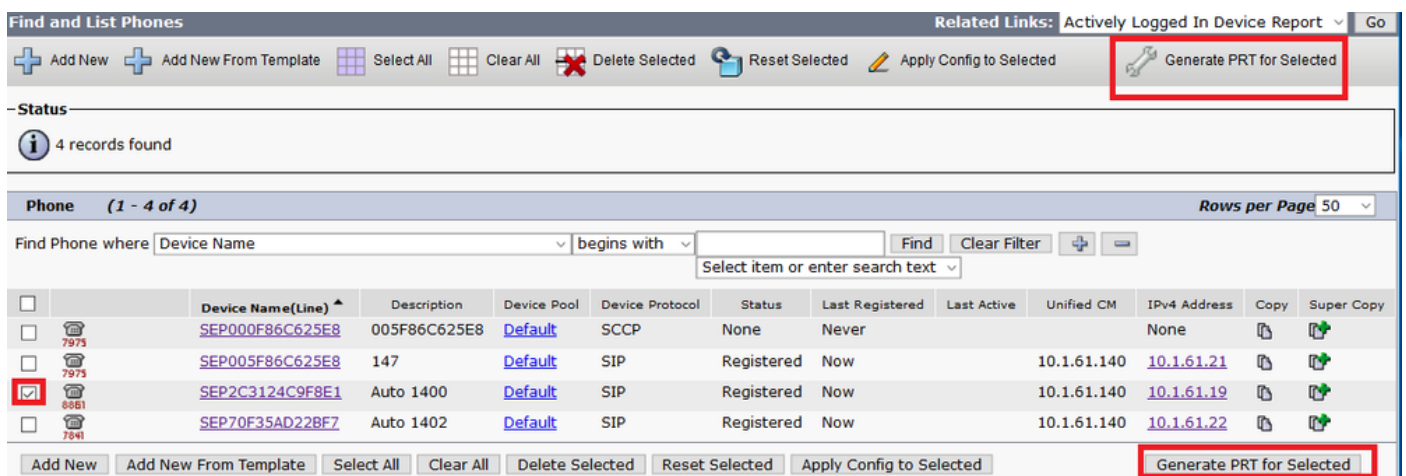
In order to generate a PRT log in to Cisco Unified Communications Manager Administration, navigate to **CM Administration > Device > Phone**, enable the checkbox of the phone of interest and select **Generate PRT for selected**, as shown in the image.

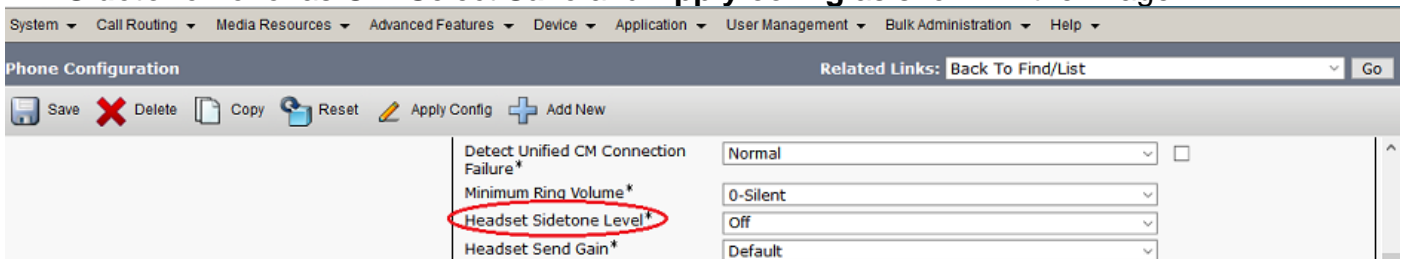
- For echo issues on Cisco 560 headset when is connected thru the Y-cable with a 7900 series phone, disable the headset sidetone level on the phone web page. Navigate to **CM Administration > Devices > Phones**, select the 7900 phones and configure the **Headset Sidetone Level** as **Off**. Select **Save** and **Apply config** as shown in the image:

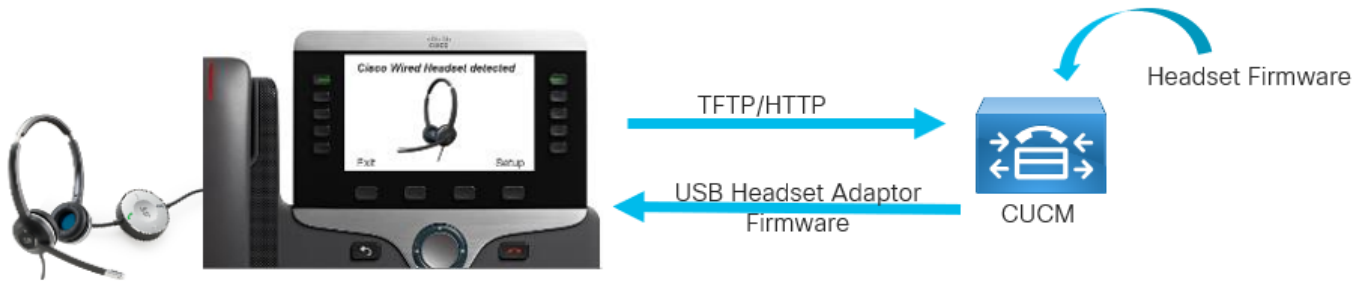
The headset firmware upgrade is decoupled from phone firmware and the upgrade happens when the headset is plugged into the phone, as shown in the image.

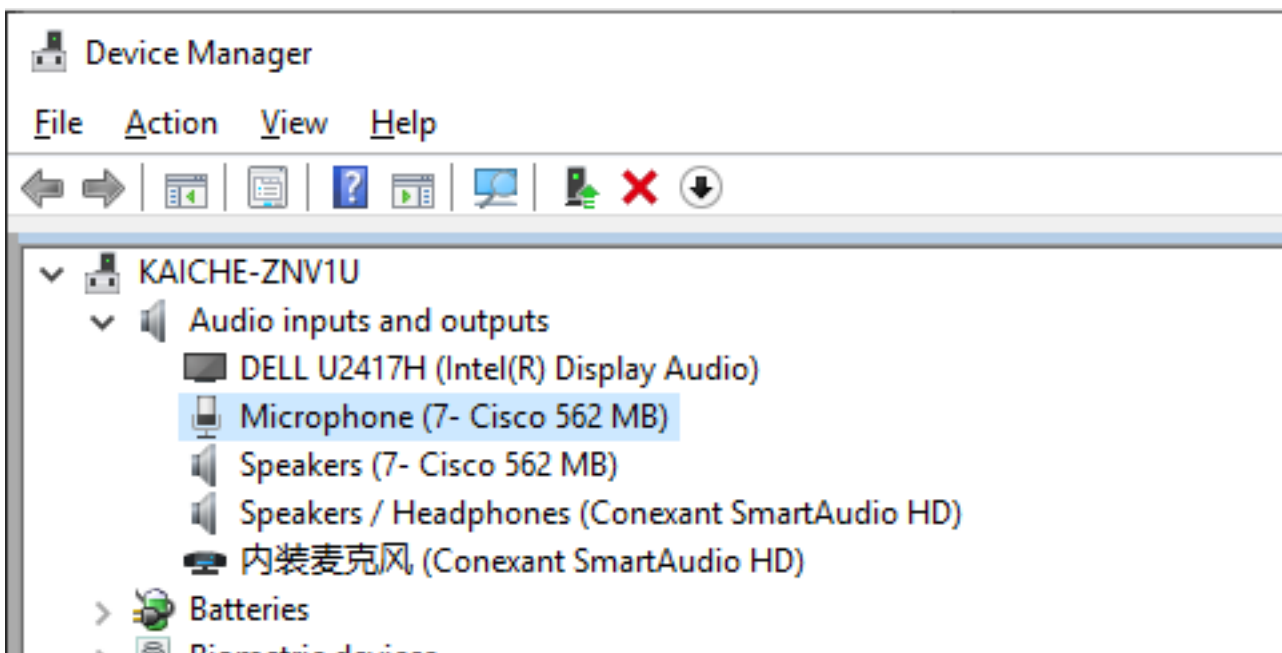
Step 2. Find the Cisco headset in the device manager under **Audio input and outputs** and select the microphone or speaker, as shown in this image.

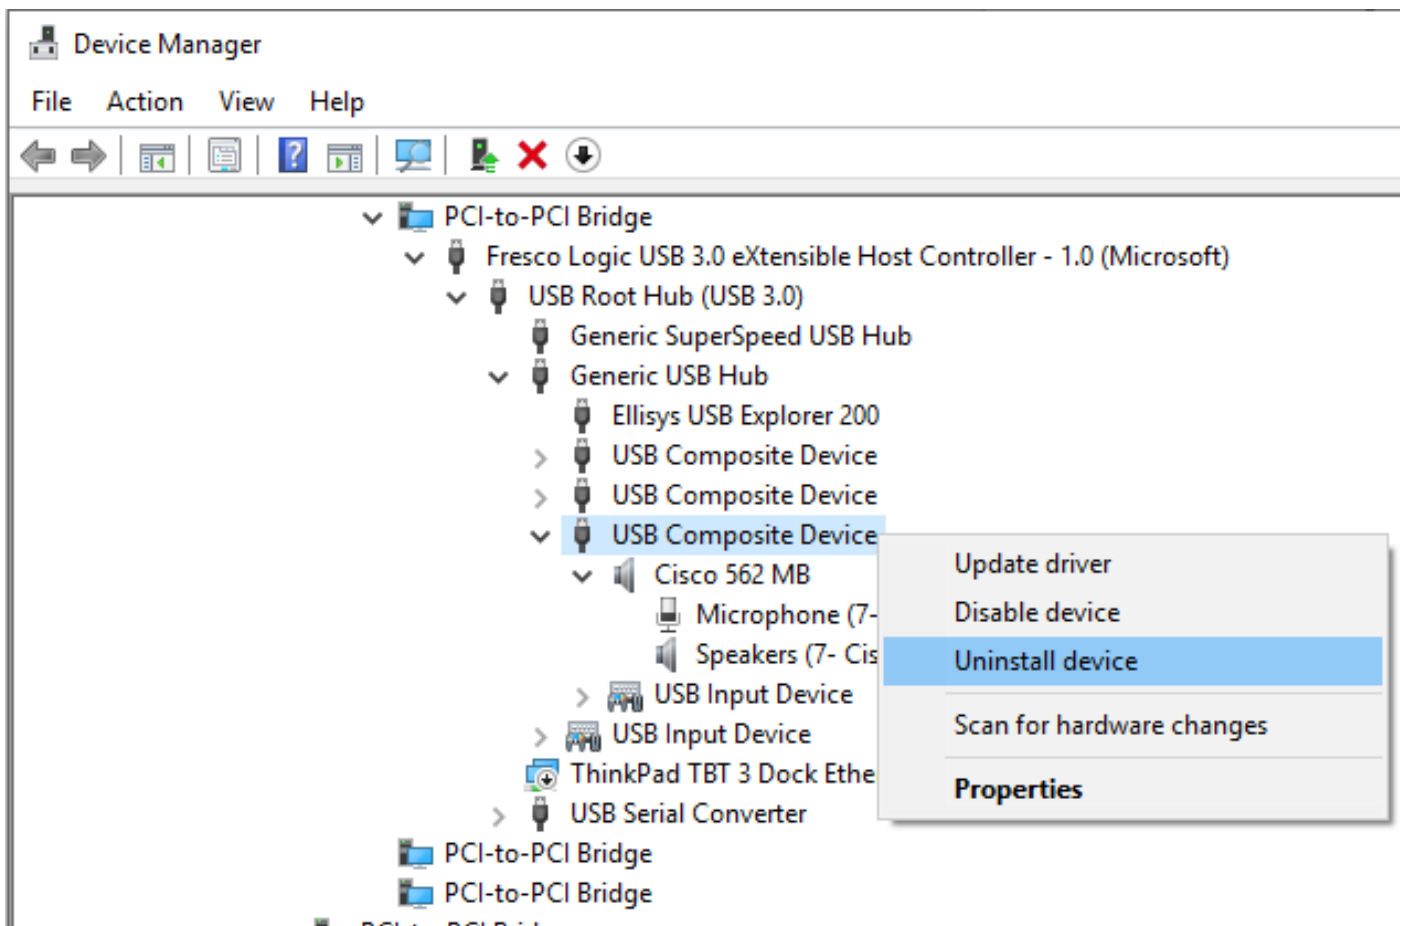
Step 4. As shown in this image, right-click **USB Composite Device** and select **Uninstall device**.
