Guida all'installazione di ISR-WAAS su router ISR serie 4000

In questo documento viene descritta la guida all'installazione di Cisco ISR-WAAS su Cisco Integrated Services Router (ISR). Si tratta dell'implementazione di virtual Wide Area Application Services (vWAAS) su un Cisco ISR.

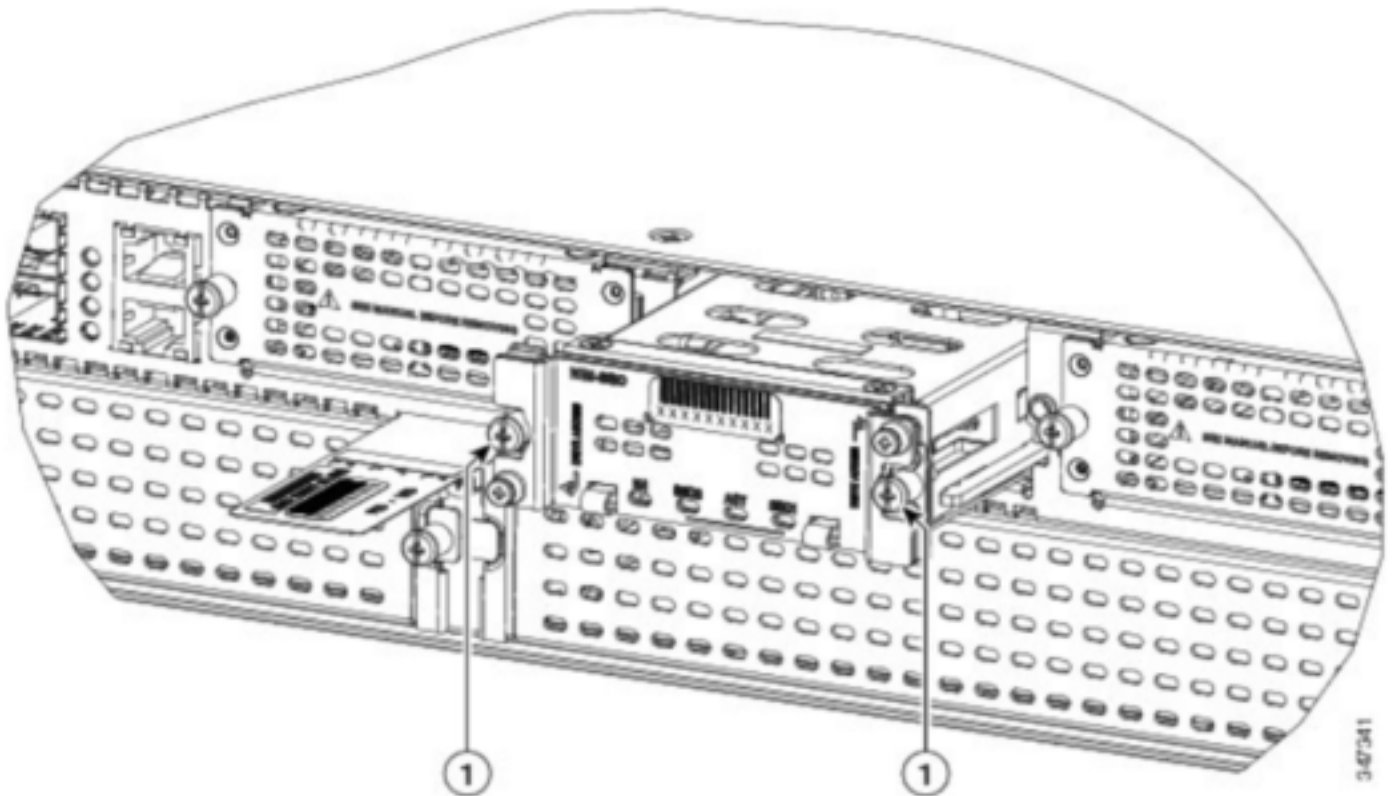
Passaggio 2. Rimuovere NIM-SSD o NIM-HDD dal router, come mostrato nell'immagine:

1 Captive screws holding the NIM-SSD to the router

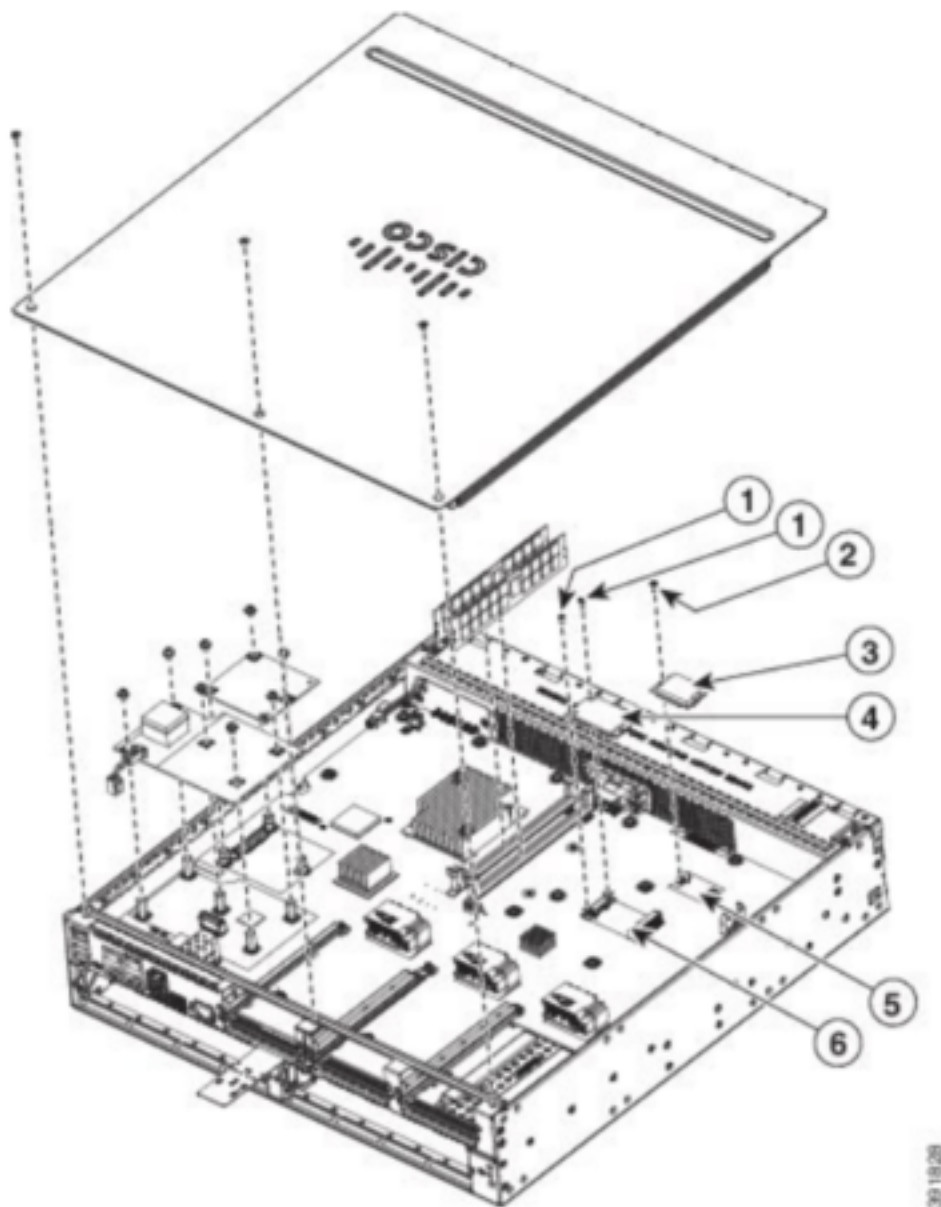
Nell'immagine sono illustrate le posizioni della scheda di memoria flash e dei dispositivi di storage SSD mSATA:

1	Supplied screw	2	Supplied screw
3	Flash memory card	4	SSD mSATA storage device
5	Flash memory card connector	6	SSD mSATA connector
